Cure Evaluation of Two Critical Composite Hybrid Flat Panels for use in a High-Dimensional Stability Satellite Application

20 July 2003

R. J. ZALDIVAR and R. CASTENEDA
Space Materials Laboratory
Laboratory Operations

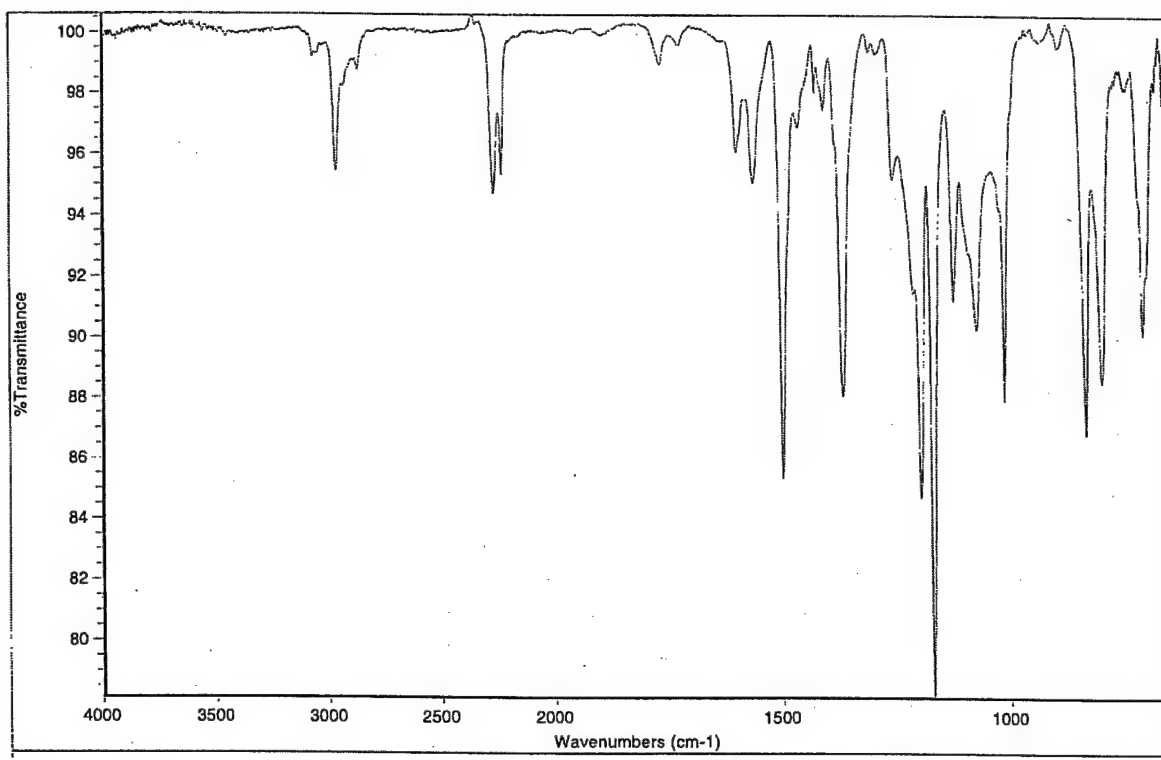
Figure 5. FTIR Spectra for typical siloxane modified cyanate ester resin.

three main areas of importance, as shown in the scans. The characteristic absorption bands of the cyanate ester groups are observed in the infrared spectrum between 2200 to 2300 cm^{-1} . The band is usually split into a doublet or triplet, depending on the chemical environment of the cyanate. Monitoring the disappearance of the cyanate ester absorbance bands can follow the polymerization of the resin. Even though this is generally a very good indicator of the degree of the initial stages of cure, identifying variations at higher degrees of cure is more difficult. A second set of peaks at 1560 and 1360 cm^{-1} reflects the absorption for the formation of the triazine ring as shown in Figure 6. The triazine ring is the primary polymerization route for this resin system. As this peak increases, the degree of cure increases; this is especially evident during the later stages of cure. Figure 6 shows an FTIR scan for the resin used in these composites as a function of the degree of cure. As shown from the figure, the polymerization can be followed quite readily for this system, especially at 1560 cm^{-1} .

The third peak to focus on is located at approximately 1750 cm^{-1} . This is a carbonyl peak that is usually indicative of hydrolysis of the cyanate ester occurring during the polymerization process. This type of carbamate contamination is the primary cause for large variations or decreases in the glass-transition temperature of the resin, even after heat treatment to high temperature. Figure 7 shows a typical FTIR with limited contamination.

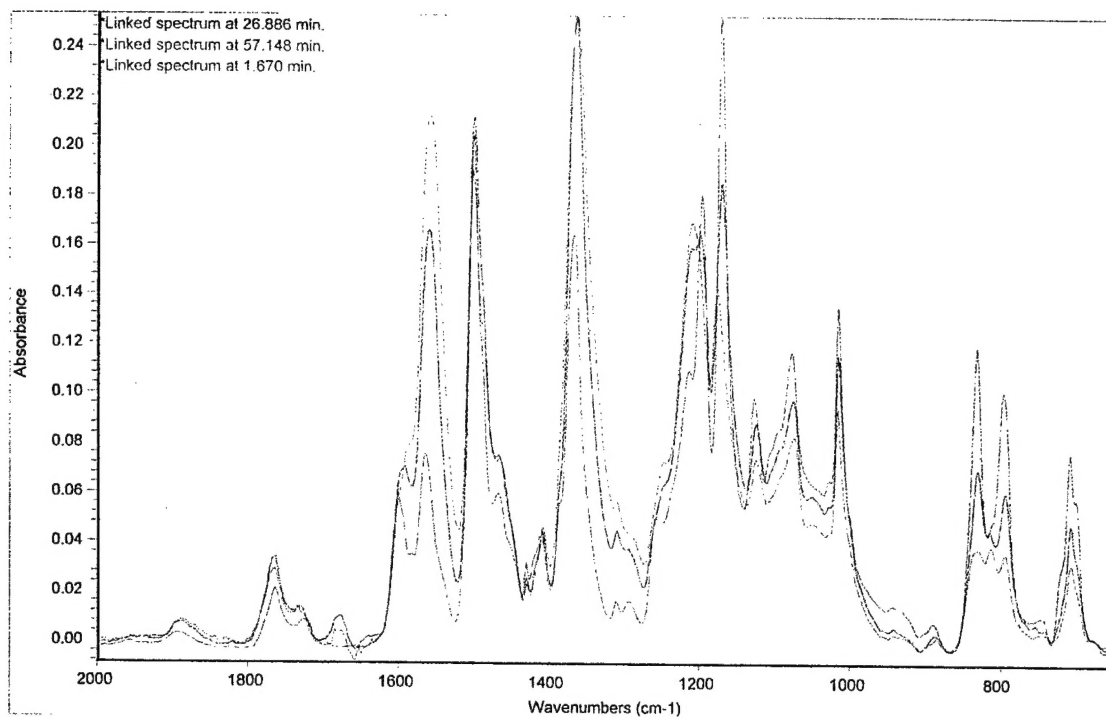
In parts from both composite panels evaluated, the cyanate peak at 2250 cm^{-1} was completely consumed. This is typical in samples that are cured over 70% unless there has been moisture contamination. In those cases, the cyanate peak can be completely consumed due to hydrolysis with a limited degree of polymerization. The degree of cure was further evaluated, normalizing the peak located at

Figure 6. FTIR Spectra showing development of triazine ring formation during cure as indicated by peaks located at 1560 and 1360 cm^{-1} .

1560 cm^{-1} for all parts taken from Panel 1 and Panel 2. Panel 2 appeared fully cured for all specimens and showed no evidence of hydrolysis contamination, which corroborates our measured Tg data. Panel 1, however, indicated a composite part that ranged in the degree of cure from 70 to 90%, depending on the location measured. The areas with the lowest degree of cure showed indications of carbamate formation. Even though by-products of hydrolysis were observed, the degree could not be easily quantified due to the convoluted nature of the peak.
